City of Chula Vista

Drainage Management System

Asset Management Plan

2016

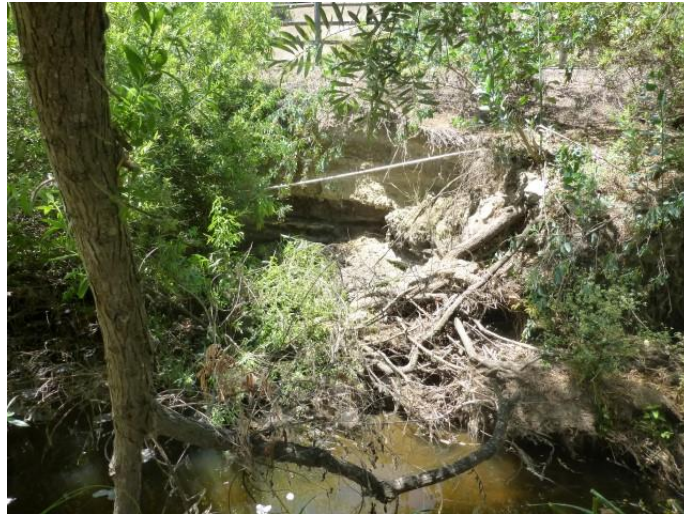
Figure 2-6 Natural Channel along Telegraph Canyon with Erosion Problem

There were some natural channels along Telegraph Canyon that had major erosion problems as shown in Figure 2-6. The details of condition assessment result are shown in Appendix A of this report.

After the condition assessment took place, the City took actions to mitigate the major erosion problems along Telegraph Canyon. In 2015, the City built a 700-foot-long secant pile wall to fix the erosion problems. The erosion control structure will last about 100 years with proper maintenance.

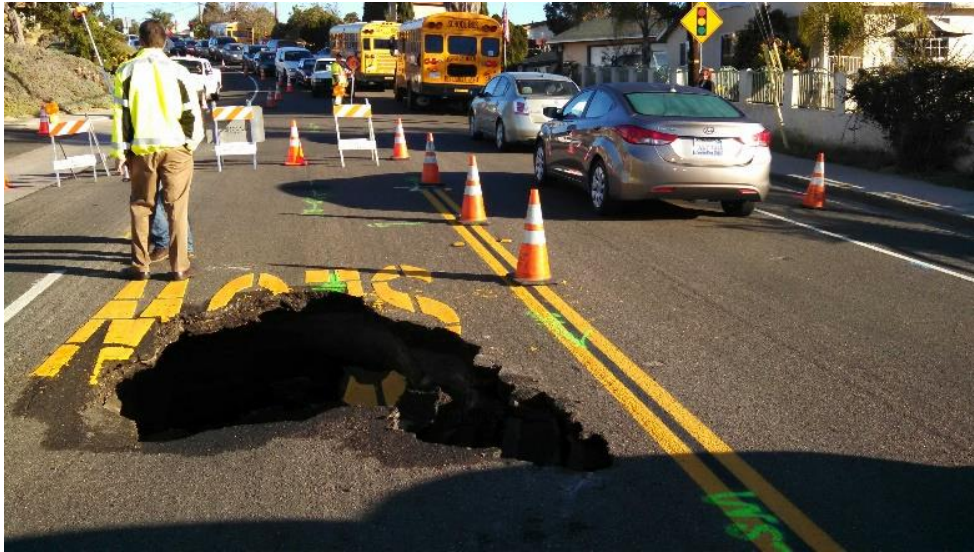
Figure 4-2 Sinkhole Caused by Pipe Failure on Oleander Ave near Valle Lindo Elementary School

failed and created a sinkhole in February 2015. Fortunately, no one was hurt during this failure. However, the social and economic impact was high for the City.

In order to prevent future failures and to drive lower life-cycle cost, the City utilized the asset management strategies. The investigation of the failed pipe revealed that it was installed in 1967. Using this data, the City decided to investigate all pre-1975 CMPs, shown in the figure below. Through visual inspection, the City hopes to capture CMPs before failure and rehabilitate the pipes by lining them. The failure cost the City around \$250,000 to fix. As a result, the City repurposed \$1.2 million from streets to prevent future failures. During this ongoing process, CMPs with condition 5 will be addressed first. Proactively rehabilitating the CMP will cost the City about 1/3 less than the replacement cost while extending the life of the pipe approximately 30 years.

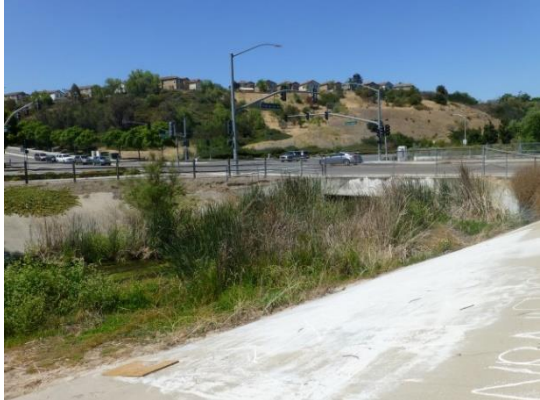
Channel	Mn15781	1992	Concrete	1522	4	Major root problem	4

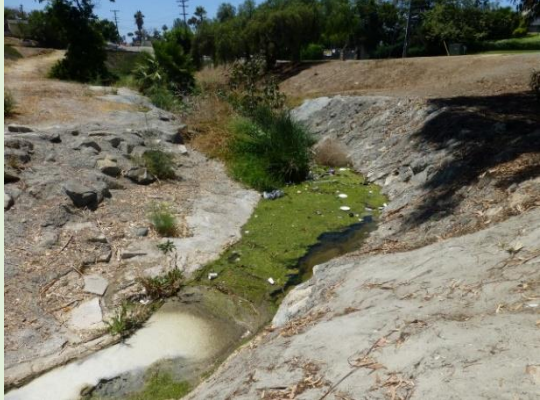
Type	Asset ID	Install Year	Material	Length (ft)	Structural Condition	Structural Condition Comment	Maintenance Condition	Maintenance Condition Comment	Image
Channel	Mn15081	1992	Riprap	238	4	Major root problem	4

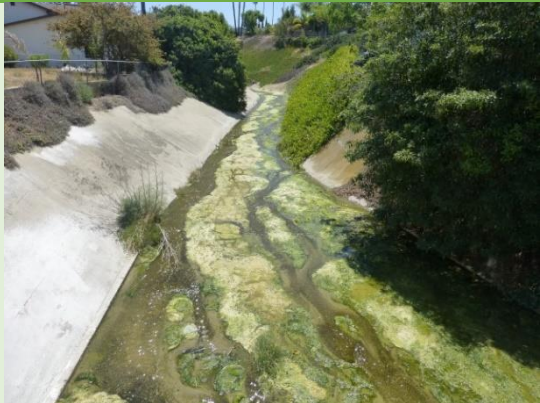
Channel	Mn17681	1978	Concrete	952	4	Major spalling/cracks (exposed rebar)	2

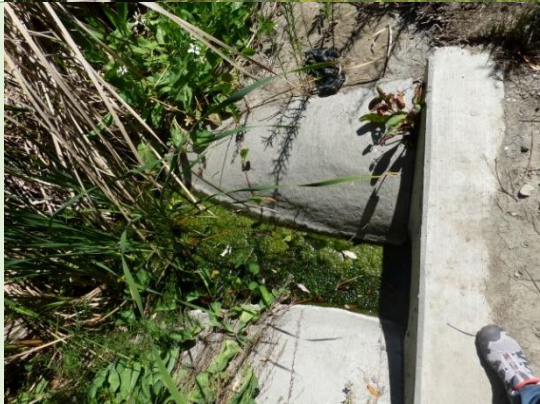
Type	Asset ID	Install Year	Material	Length (ft)	Structural Condition	Structural Condition Comment	Maintenance Condition	Maintenance Condition Comment	Image
Head wall Outlet	JC3355	1977					2	3-Minor blockage (trash/small debris)

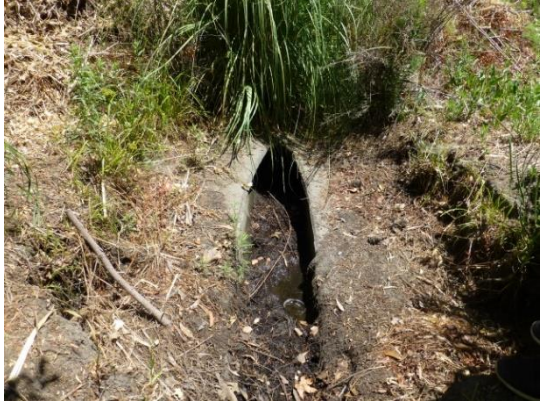
Head wall Outlet	JC3357	1980					4	Major blockage (large debris)/ Tree blocking

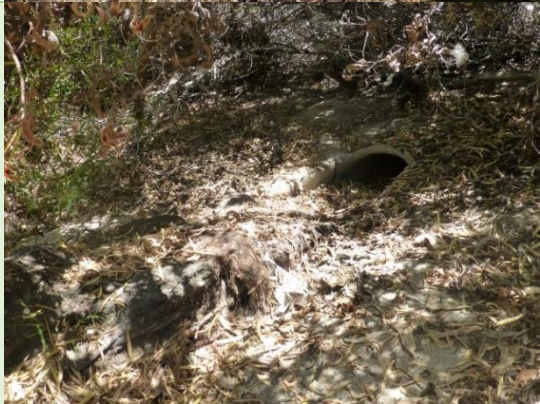
Type	Asset ID	Install Year	Material	Length (ft)	Structural Condition	Structural Condition Comment	Maintenance Condition	Maintenance Condition Comment	Image
Head wall Outlet	JC3359	1989					4	Major blockage (large debris)

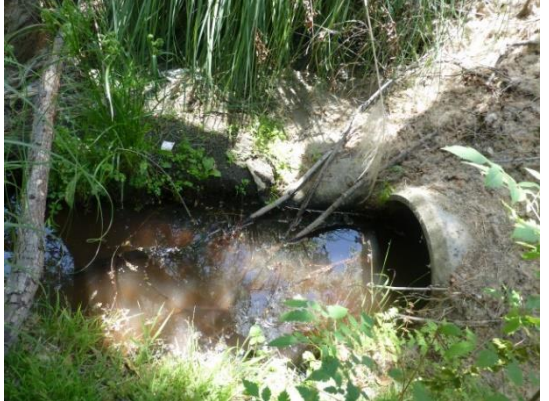
Head wall Outlet	JC5052	1975					4	Major blockage (large debris)
