# City of Chula Vista Pedestrian Connectivity Plan

August 2019

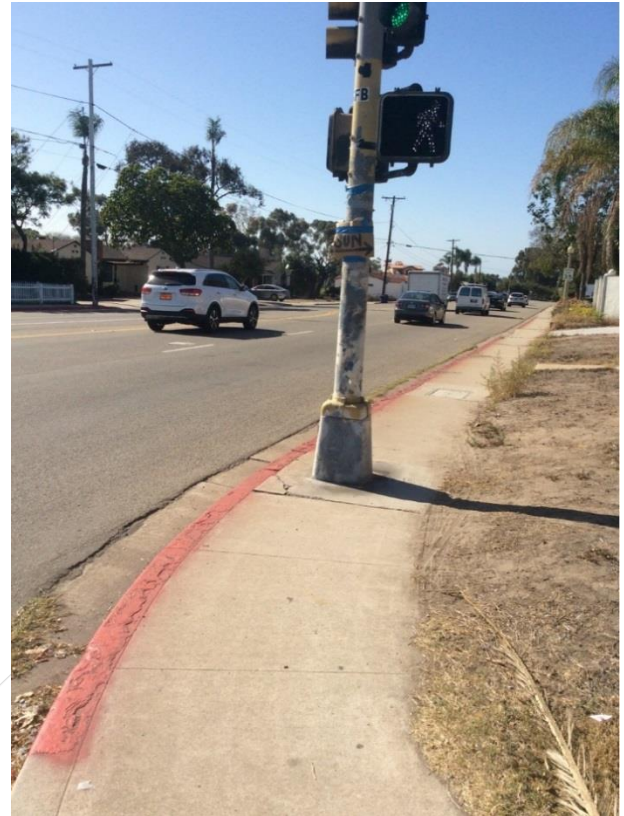
1. Sidewalk Obstructions\Protrusions

Utility	500
Sign	380
Temporary	886
Overhead Vegetation Protrusion	4613
Side Vegetation Protrusion	2872
Traffic Signal	91
Misc.	22
Others	136
Uneven Heaving	14
<b>Total</b>	<b>9,514</b>

Sidewalk Obstruction

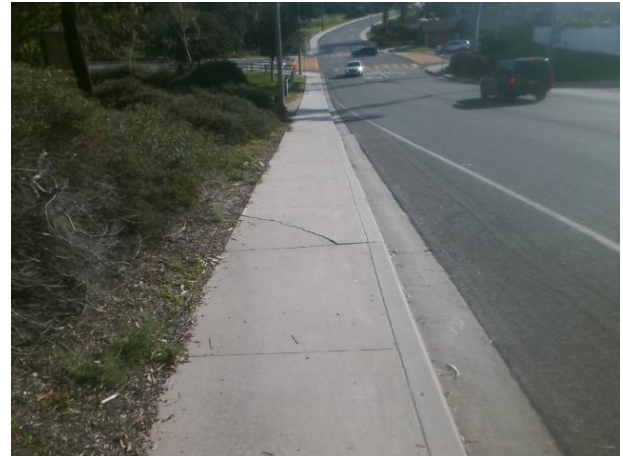
2. Sidewalk Changes in Level (Heaves)

<b>1/4" – 1/2"</b>	<b>29,431</b>
<b>1/2" - 3/4"</b>	<b>6,675</b>
<b>3/4" - 1"</b>	<b>3,257</b>
<b>1"+</b>	<b>2,709</b>
<b>Total</b>	<b>42,072</b>

**Sidewalk Changes in Level (Heaves)**

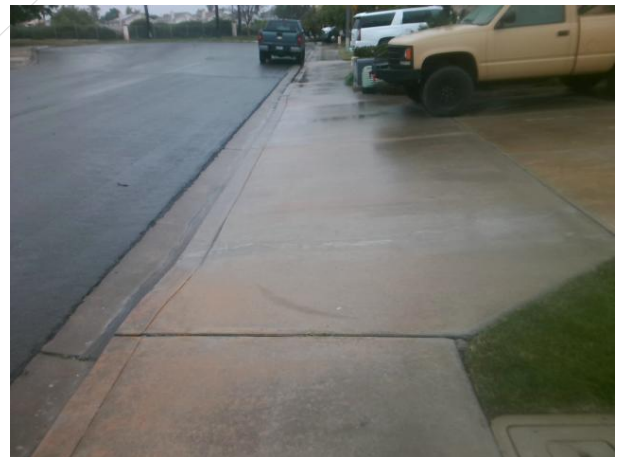
3. Sidewalk Cross Slope

<b>2.01 - 3%</b>	<b>198.92 miles</b>
<b>3.01 - 4%</b>	<b>100.81 miles</b>
<b>4.01-5%</b>	<b>42.88 miles</b>
<b>5.01%-6%</b>	<b>29.39 miles</b>
<b>6.01%-7%</b>	<b>17.26 miles</b>
<b>7%+</b>	<b>50.0 miles</b>
<b>Total</b>	<b>432.58 miles</b>

**Steep Cross Slope - Driveway**

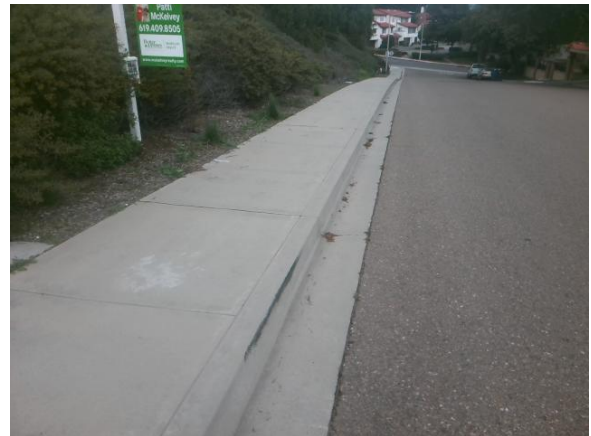
4. Sidewalk Run Slope

<b>5.01% – 8.33%</b>	<b>115.45 miles</b>
<b>8.34% - 10%</b>	<b>23.91 miles</b>
<b>10.01% - 12.5%</b>	<b>19.00 miles</b>
<b>&gt;12.5%</b>	<b>7.65 miles</b>
<b>Total</b>	<b>166.01 miles</b>

Sidewalk Run Slope

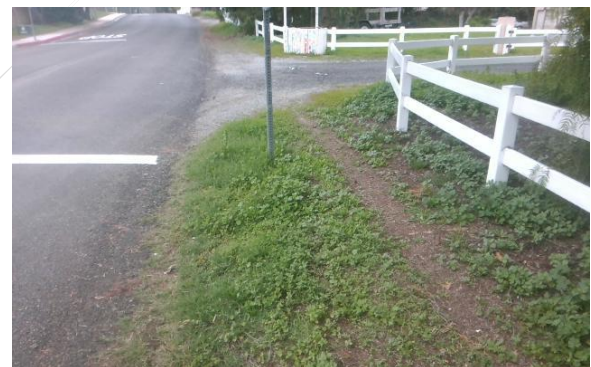
5. Sidewalk Connectivity

<b>Sidewalk Gap</b>	<b>19.74 miles</b>
<b>No Sidewalk</b>	<b>53.00 miles</b>
<b>Buried Sidewalk</b>	<b>0.12 miles</b>
<b>Narrow Sidewalk</b>	<b>2.31 miles</b>
<b>Total</b>	<b>75.17 miles</b>

Sidewalk Connectivity

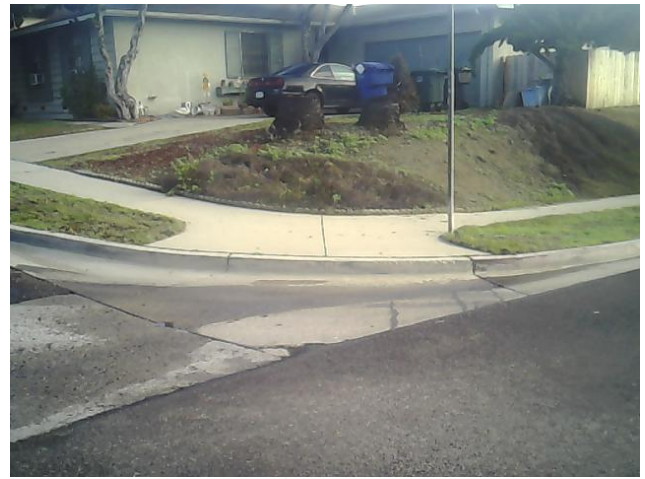
- Of the 2,670 missing curb ramps, 2,413 represent missing ramps within T-Intersections. These are often in residential areas where the City will need to review each curb ramp compliance details and the overall corridor for the best design solutions. Additionally, the inventory assessment was based upon the ultimate design of three crosswalks at each T-intersection which is typically reduced to two in residential areas. In many cases, installing ramps would conflict with existing driveways, drainage facilities, or accessible parking. Currently the missing ramps within T-Intersections represent \$4,826,000 of improvements but, each location will require additional review by city staff to determine a realistic solution for creating the best accessible path of travel. The number of missing ramps and costs for improvements should decrease, as design solutions and actual remediation plans for these sites evolve during the advanced planning process.

A very high percentage, 90.1%, of the 2,670 missing ramps are represented in areas identified as “T-Intersections”. In these locations, some missing ramps may be remediated with signage and physical barriers eliminating an unmarked pedestrian crossing. Other design solutions may be found to address these areas and the City will be evaluating these locations.

**Missing Curb Ramp**

5. **Missing ramps** will be considered a high priority. Given the majority of missing ramps reside in T-intersection locations, these will be evaluated by city staff and reviewed in their entirety. Staff will identify the most viable locations for pedestrian crossing, and crosswalks and ramps will be proposed where appropriate. Other design solutions, such as directional ramps, signage or barriers may also be utilized to discourage use where a crosswalk is unmarked and is not intended.

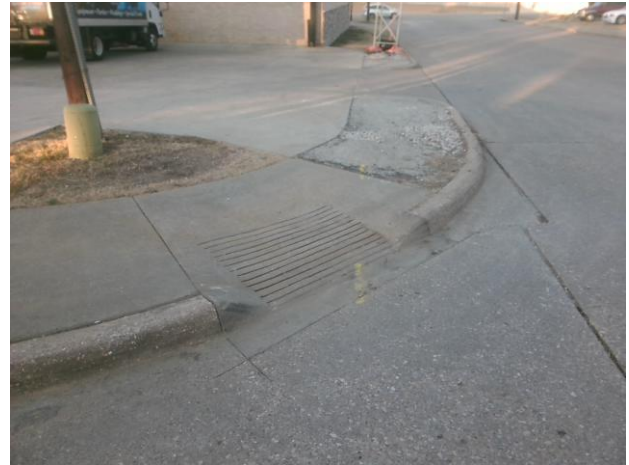
2. Curb Ramp Running Slope

0 – 5.0%	368
5.01% – 8.33%	2077
8.34% - 10%	2760
10.01% - 12.5%	1530
>12.5%	577
<b>Total</b>	<b>7312</b>

Curb Ramp Running Slope

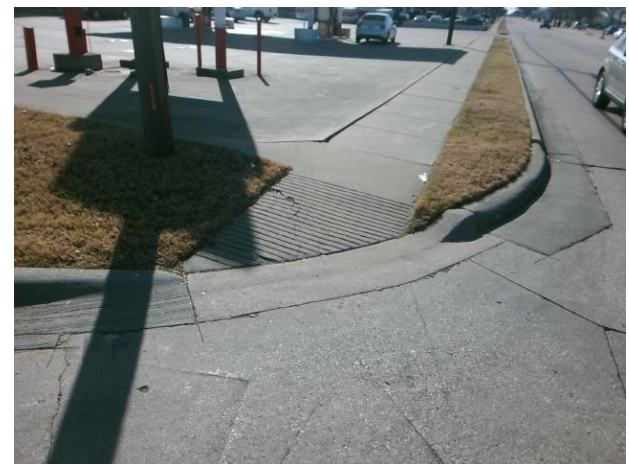
3. Curb Ramp Cross Slope

<= 2.0%	3730
2.01% – 3.0%	1262
3.01% - 4.0%	747
4.01% - 5.0%	496
5%+	1077
<b>Total</b>	<b>7312</b>

Curb Ramp Cross Slope

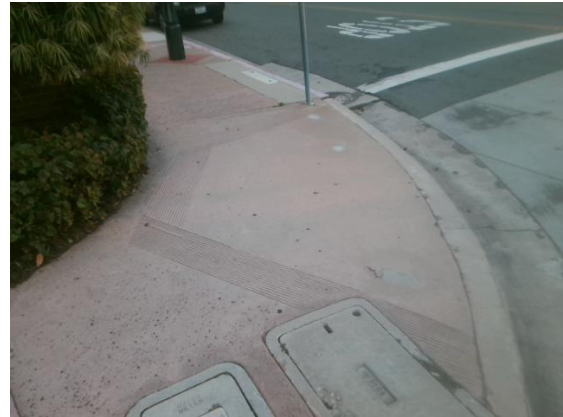
4. Curb Ramp Landing Slopes

<b>Not per PROWAG recommendation</b>	<b>749</b>
<b>Meets PROWAG recommendation</b>	<b>692</b>
<b>No Landing</b>	<b>9</b>
<b>* Not Assessed</b>	<b>5,867</b>

**Landing Slope**

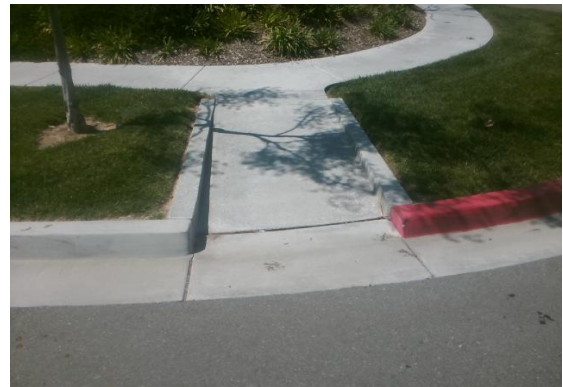
5. Detectable Warning Surfaces

<b>DWS: Missing</b>	<b>429</b>
<b>DWS: Compliant</b>	<b>933</b>
<b>DWS: Deviates from Standard</b>	<b>25</b>
<b>* Not Assessed</b>	<b>5,870</b>

**Curb Ramp Detectable Warning Surface-Missing**

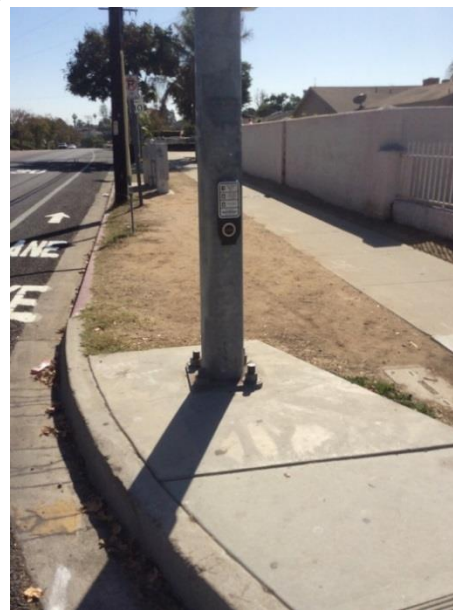
1. Pedestrian Pushbuttons per post

<b>1</b>	<b>1445</b>
<b>2</b>	<b>114</b>
<b>No Pushbutton</b>	<b>269</b>
<b>Total Signal Posts Assessed</b>	<b>1828</b>

**Pedestrian Pushbutton Per Post**

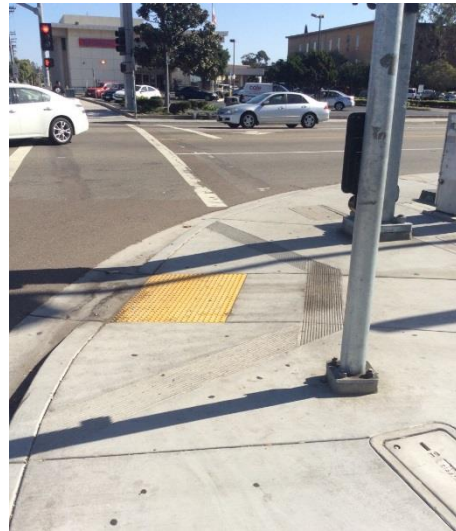
2. Pushbutton Distance to Curb

<b>Compliant</b>	<b>1130</b>
<b>Deviates from Standard</b>	<b>543</b>
<b>No Pushbutton</b>	<b>269</b>
<b>Total</b>	<b>1942</b>

Pushbutton Distance to Curb

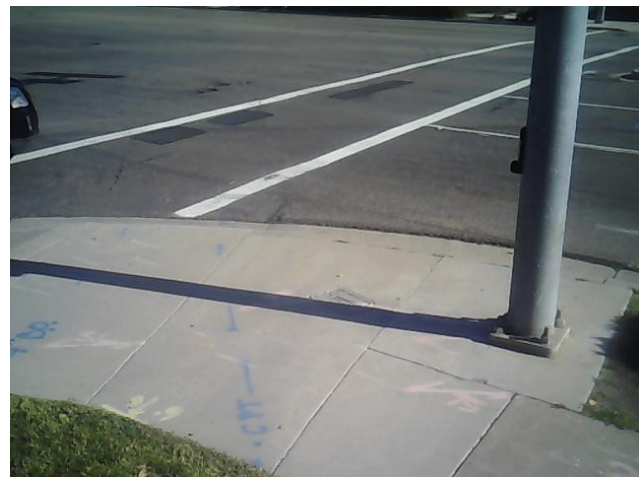
3. Pushbutton Distance to Crosswalk

<b>Compliant</b>	<b>1233</b>
<b>Deviates from Standard</b>	<b>440</b>
<b>No Pushbutton</b>	<b>269</b>
<b>Total</b>	<b>1942</b>

Pushbutton Distance to Crosswalk

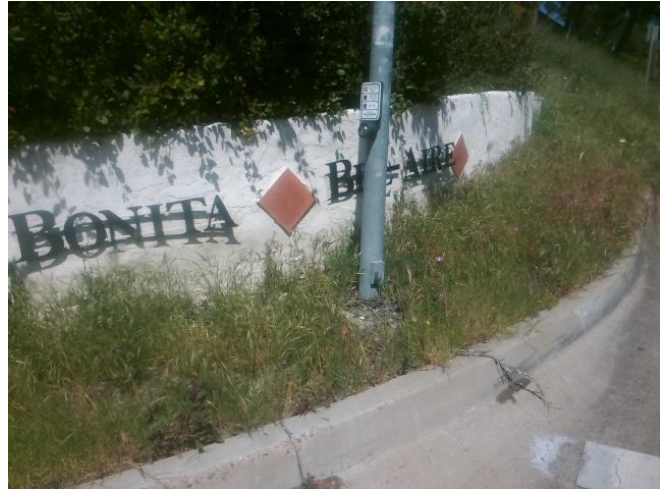
4. Clear Floor Space

<b>Compliant</b>	<b>1303</b>
<b>Deviates from Standard</b>	<b>370</b>
<b>No Pushbutton</b>	<b>269</b>
<b>Total</b>	<b>1942</b>

Pushbutton Clear Floor Space - Missing
