City of Chula Vista

Drainage Management System

Asset Management Plan

2016

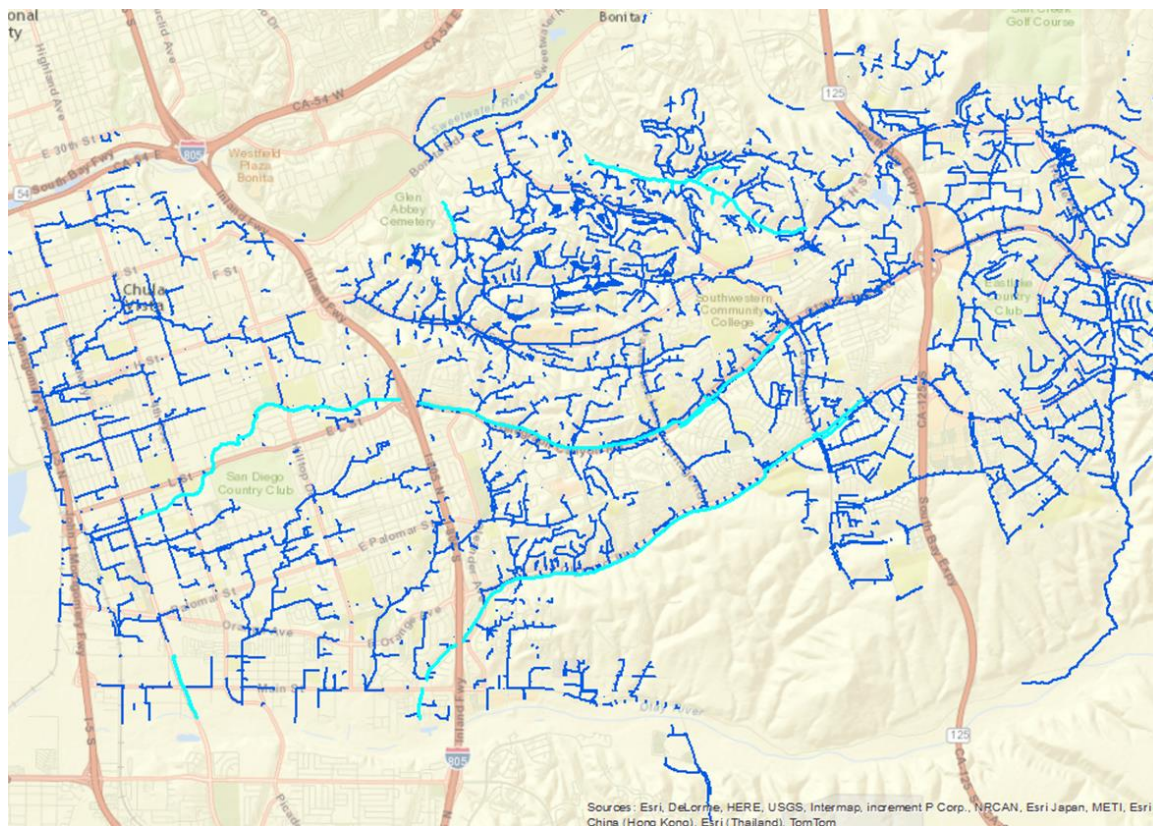
Figure 2-5 Condition Assessed Channels

These assessment values were considered in the estimation of remaining useful lives. Figure 2-5 highlights the areas of channel where the condition assessment was performed in light blue. There was a total 7 miles out of 77 miles (9%) of channels on which the sample condition assessment was performed.

In general, the structural condition of the concrete channels was sound; however, the sample channels assessed generally had vegetation and sediment problems. GPS coordinates of problematic areas in the channels have been collected in order to highlight these assets in the database and assign different management strategies to mitigate the problem.

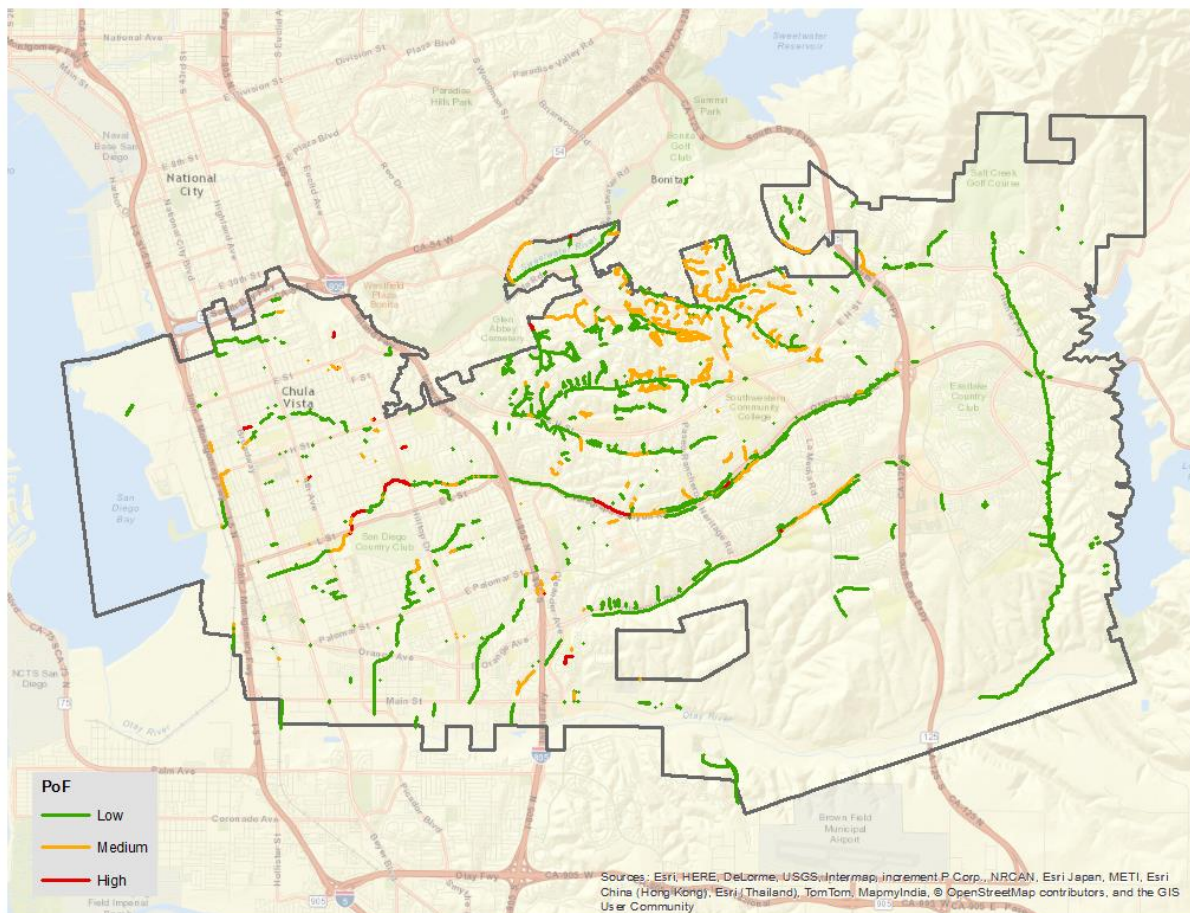
Figure 3-1 Probability of Failure of Channels

Figure 3-1 below summarizes the PoF distribution for channels, including box culverts, rivers, streams, and brow ditches. Of the total 84 miles of assets, approximately 71% (60 miles) have a low probability of failure, 27% (23 miles) have a medium probability of failure, and approximately 2% (2 miles) are estimated to have a high probability of failure. The channels with high probability of failure have been classified as such mainly due to maintenance issues, such as heavy vegetation, debris, or sediment, and not due to structural issues. Although regular maintenance is ideal, stringent regulations require permits in order to perform maintenance. Acquiring permits to enter the channel often takes several months to a year. This stringent permitting requirement and its long process significantly lessens the frequency of maintenance in these channels.

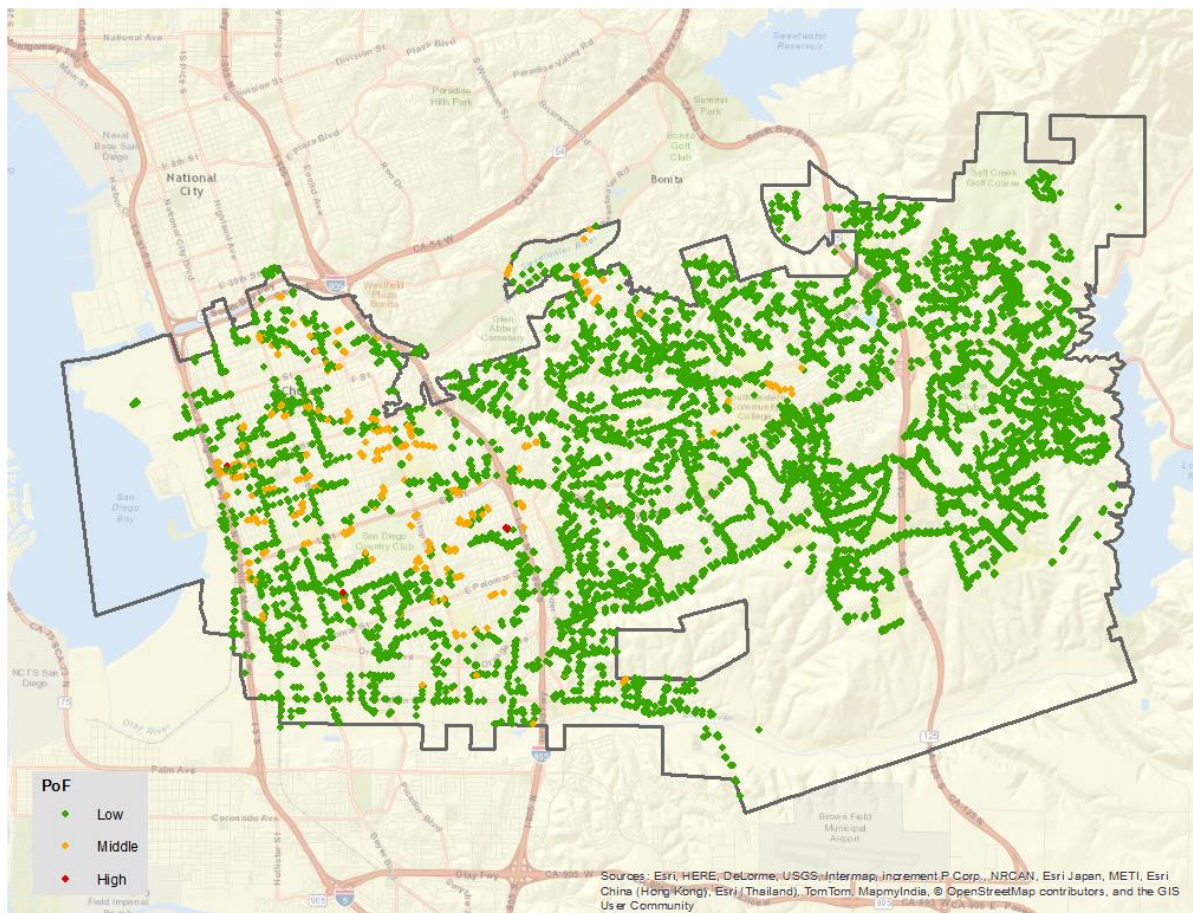
Figure 3-2 Probability of Failure of Junctions

Figure 3-2 below summarizes the PoF distribution for junctions (e.g., inlet, outlet, filterra, catch basin). Of the 10,552 assets, approximately 96% (10,109) have low probability of failure, 4% (432) have medium probability of failure, and less than 1 % (11) are estimated to have high probability of failure. As expected, the junctions located on the western side of the City have more medium and high probability of failure assets due to age. Most high PoF junctions are plates and grates installed between the mid-1950s and mid-1970s. With estimated useful lives of 40 and 50 years, respectively, these plates and grates have reached the ends of their useful lives and will soon require replacement. A condition assessment of high PoF assets is warranted to verify the projected condition. If required based on the results of the condition assessment, the estimated useful life may be extended or shortened to reflect the true condition of the assets. Other high PoF assets included headwall outlets along the channels with sedimentation and vegetation problems.

For inlets, condition assessment meant to be done routinely (i.e., every 3 years). However, the City is currently in the process of catching up on 10 years of deferred condition assessment. The PoF scores are being used to prioritize the condition assessment and field verification process. The results of these assessments will then be incorporated into the life-cycle cost logic.

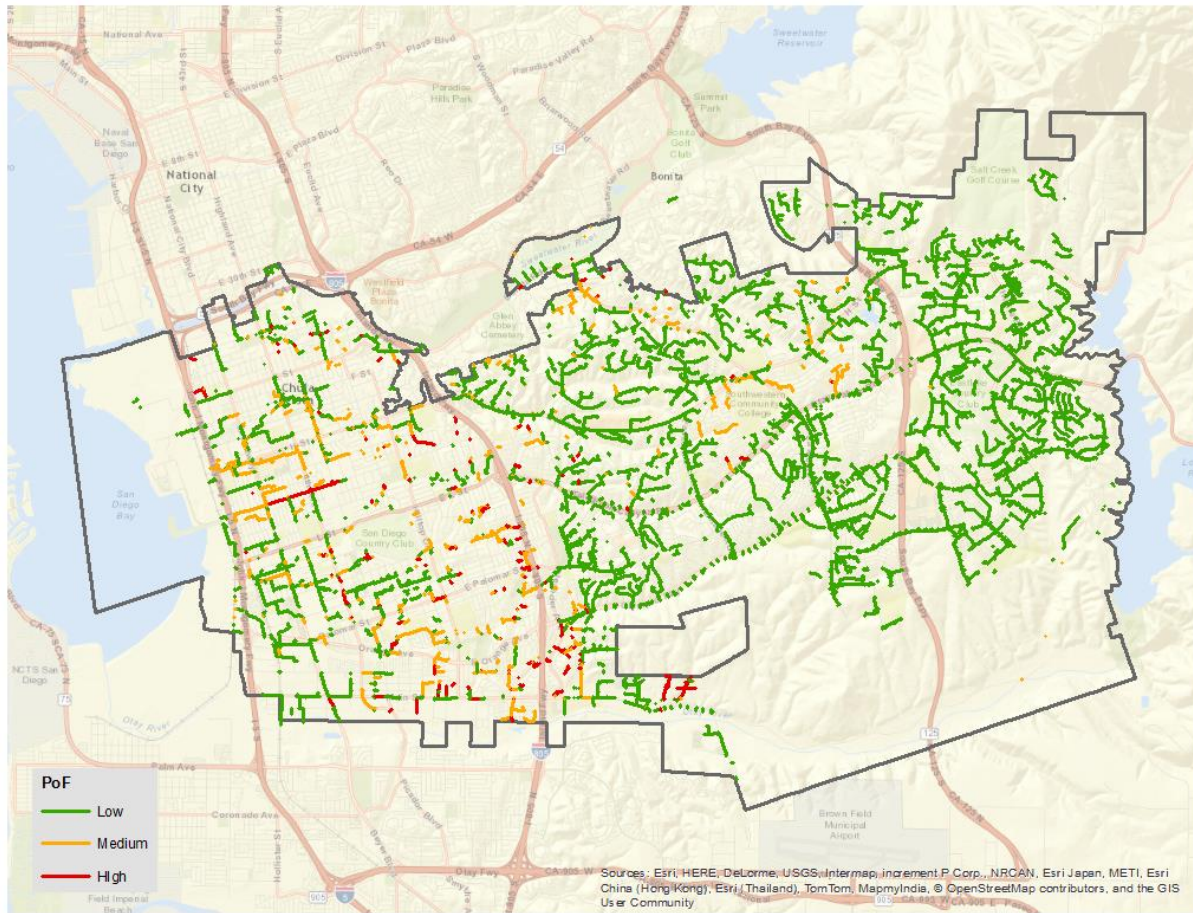
Figure 3-3 Probability of Failure of Pipes

Figure 3-3 summarizes the PoF distribution for drainage pipes. Of the total 207 miles, approximately 85% (175 miles) have low probability of failure, 11% (24 miles) have medium probability of failure, and 4% (8 miles) are estimated to have high probability of failure. As expected, the CMPs located on the west side of the City are showing more medium and high probability of failure due to age and corrodible material. Out of 13 miles of CMPs, more than 65% (8 miles) were identified as high PoF. In 2015, the City has taken initiative to perform another CCTV inspection in order to determine the current condition of the CMPs. The CCTV results are currently being reviewed in order to identify the immediate needs area.

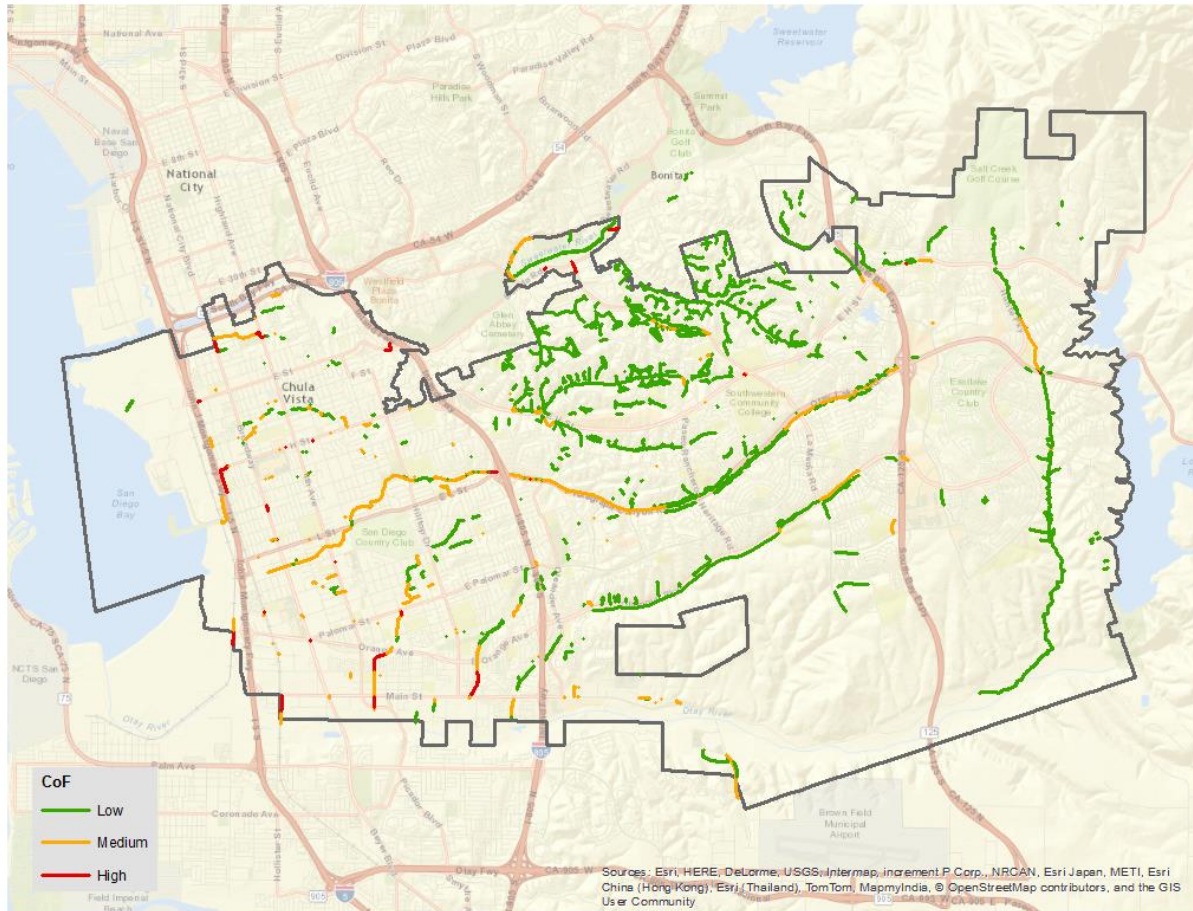
Figure 3-4 Consequence of Failure of Channels

Figure 3-4 summarizes the consequence of failure for channels, which includes box culverts, rivers, streams, and brow ditches, as a result of the calculation logic shown in previous tables. Of the total 84 miles, approximately 77% (65 miles) are identified to have low consequence of failure, 20% (17 miles) have medium consequence of failure, and approximately 3% (3 miles) have high consequence of failure. As the map shows, large channels located close to major roads and highways were assigned medium or high consequence of failure.

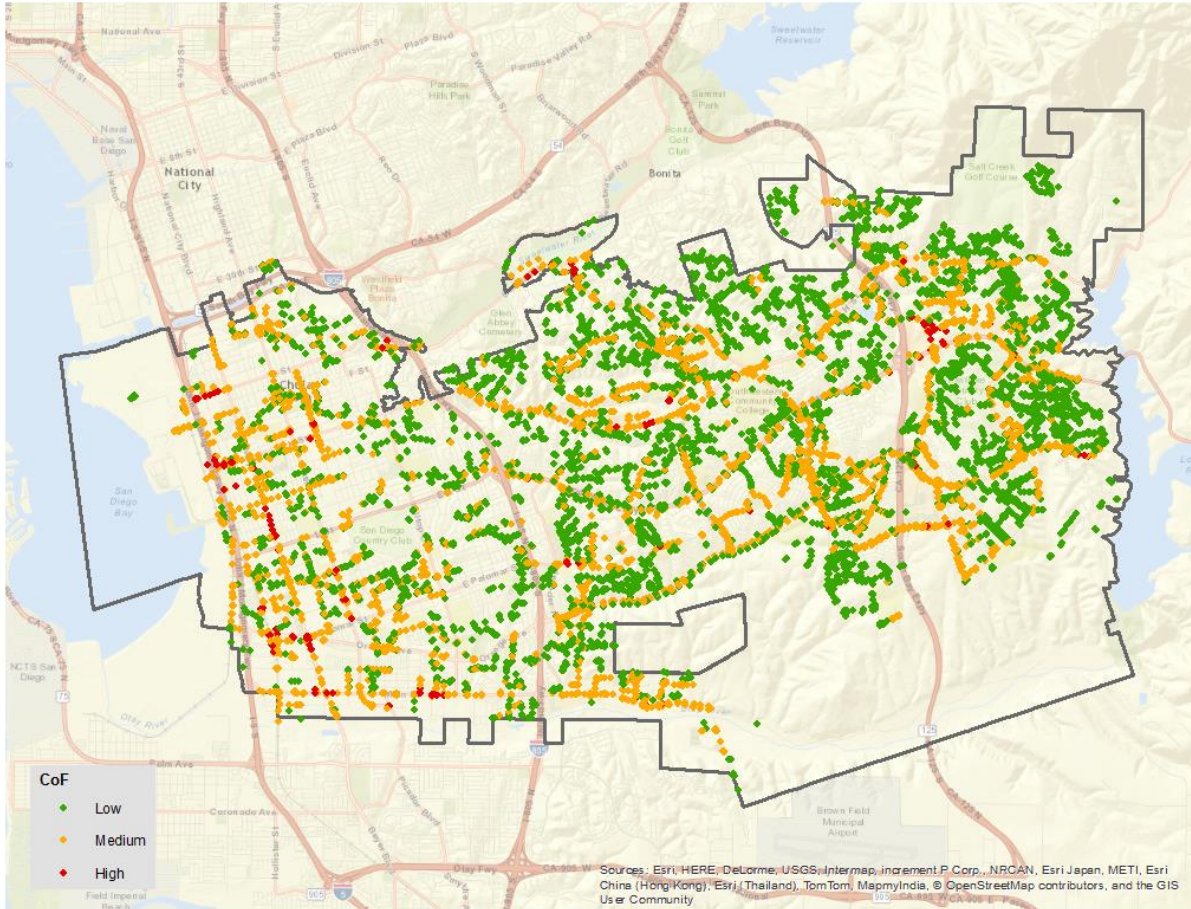
Figure 3-5 Consequence of Failure of Junctions

Figure 3-5 summarizes the consequence of failure for junctions (e.g. inlet, outlet, filterra, catch basin). Of the total 10,552 assets, approximately 61% (6,467) have low consequence of failure, 37% (3,888) have medium consequence of failure, and less than 2% (197) have high consequence of failure. The junctions that were generally located near the major roads, highways, or railroads had medium to high consequence of failure due to the high traffic and large impact of a failure in these areas.

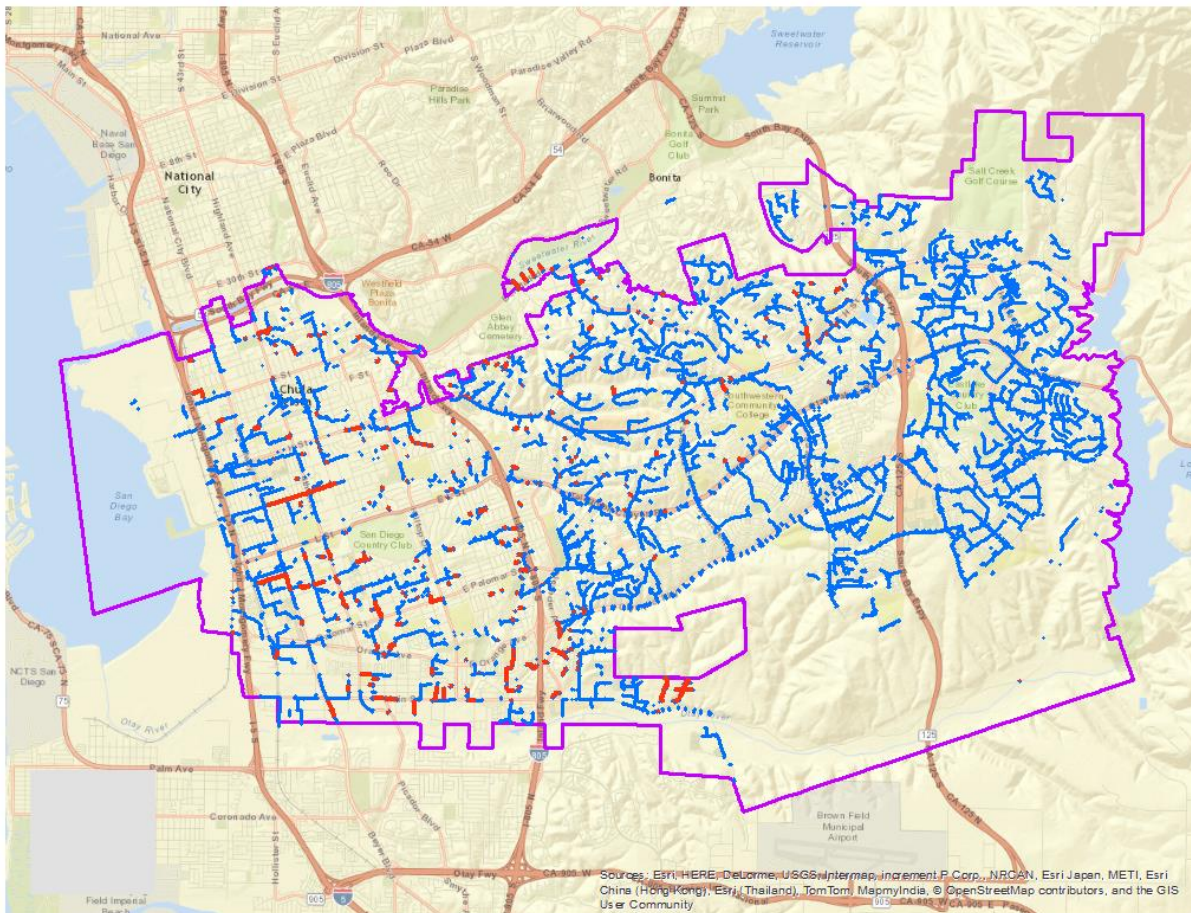
Figure 4-1 Corrugated Metal Pipes

The City's drainage assets are mostly in good shape. However, some of the corrugated metal pipes (CMP) are starting to deteriorate due to their age and the corrodible nature of the material.

In 2005, the City has performed condition assessment on all the CMP in the City using CCTV. As shown in Figure 4-1, most of the CMPs, highlighted in red, are located in the older parts of the City, especially around the downtown area.

There are approximately 13 miles of CMP located in the City. 85% (8 miles) of these pipes have consumed 85% or more of their useful lives and need immediate attention. According to 2005 condition assessment (i.e., CCTV) data, 1.8 miles of CMPs were recommended to be lined with CIPP liner and 0.4 miles of CMPs were recommended to be replaced immediately.

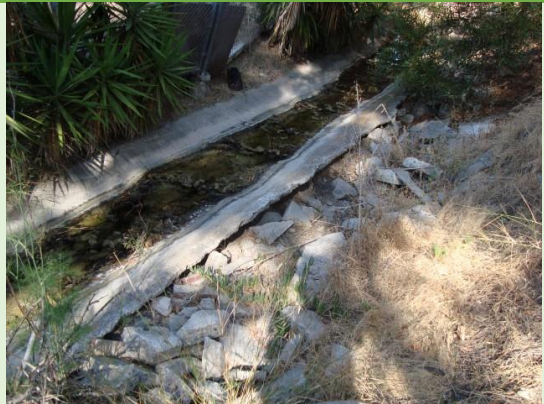
Type	Asset ID	Install Year	Material	Length (ft)	Structural Condition	Structural Condition Comment	Maintenance Condition	Maintenance Condition Comment	Image
Channel	Mn17541	1979	Concrete	42	4	Major spalling/cracks (exposed rebar)	2

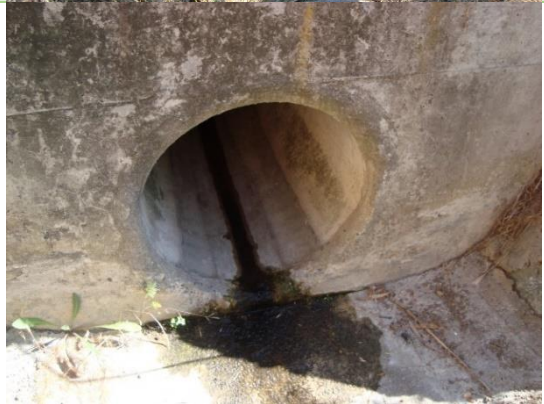
Channel	Mn14862	0	Natural	657			4

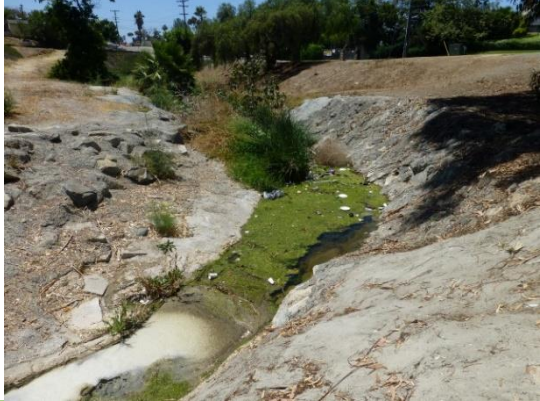
Type	Asset ID	Install Year	Material	Length (ft)	Structural Condition	Structural Condition Comment	Maintenance Condition	Maintenance Condition Comment	Image
Channel	Mn15081	1992	Riprap	238	4	Major root problem	4

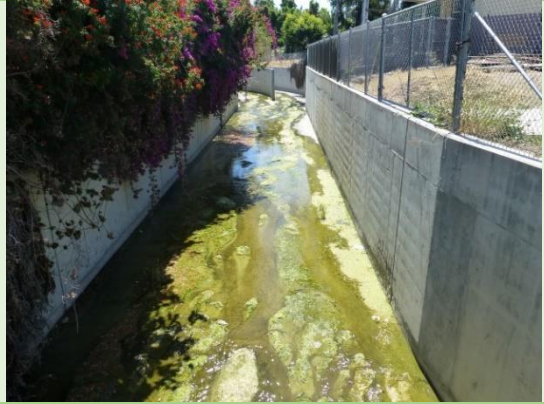
Channel	Mn14863	0	Channel	137			4

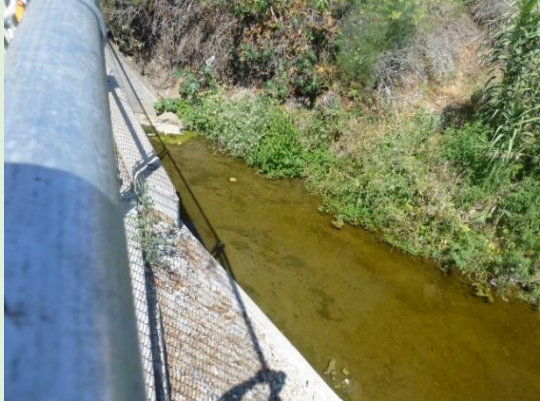
Type	Asset ID	Install Year	Material	Length (ft)	Structural Condition	Structural Condition Comment	Maintenance Condition	Maintenance Condition Comment	Image
Channel	Mn24354	1995	Concrete	328			4

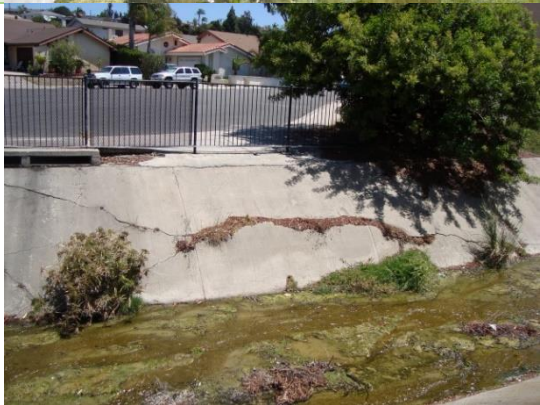
Channel	Mn17681	1978	Concrete	952	4	Major spalling/cracks (exposed rebar)	2

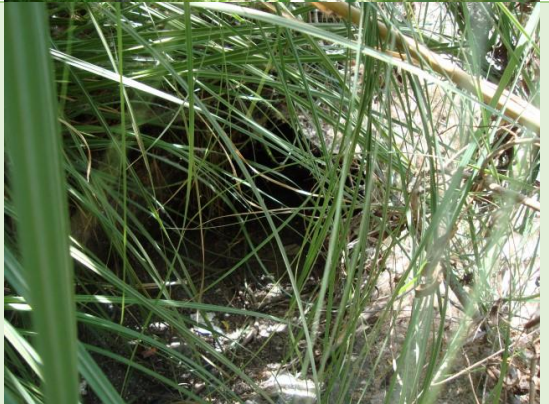
Head wall Outlet	JC5052	1975					4	Major blockage (large debris)
