**LIMITED
GEOTECHNICAL INVESTIGATION**

**COLLINS AEROSPACE
REDEVELOPMENT SITE – PARCEL B
NORTHEAST CORNER OF
H STREET AND MARINA PARKWAY
CHULA VISTA, CALIFORNIA**

**MARCH 3, 2021
PROJECT NO. G2560-52-01**

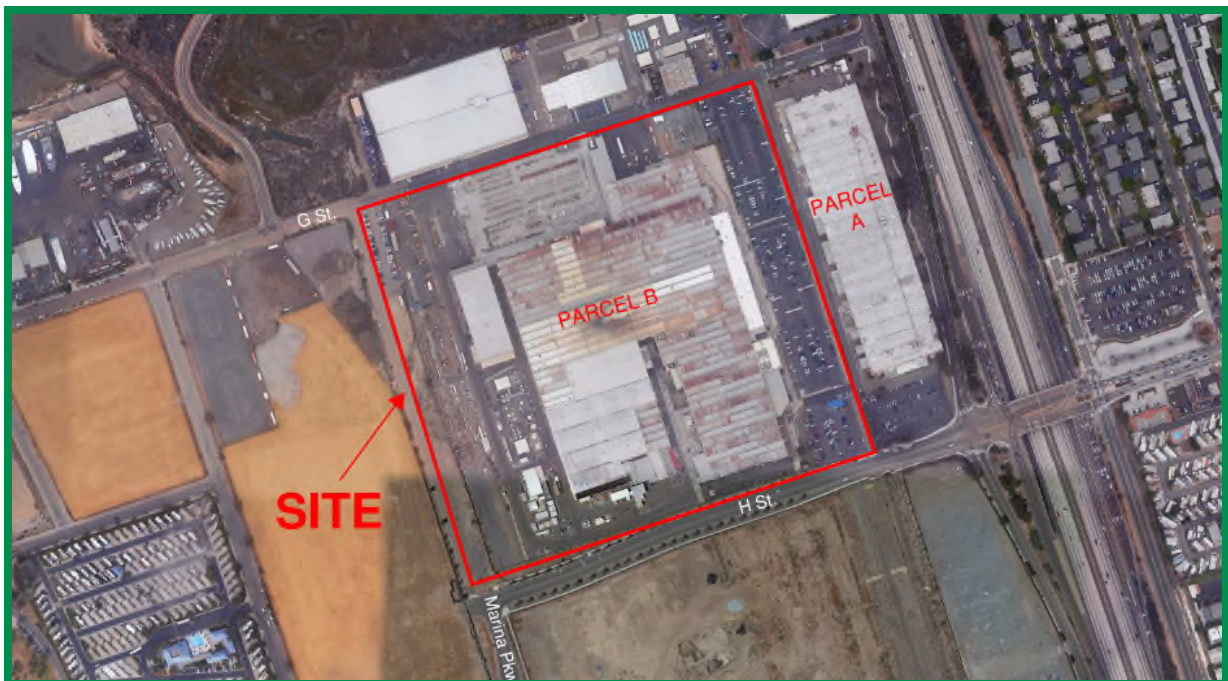
The Collins Aerospace – Parcel B property consists of the western portion of the existing Collins Aerospace facility (also identified as Rohr Industries, B. F. Goodrich and/or UTC Aerospace property). The Existing Site Map shows the current site conditions.

The property is bounded by H Street to the south, Marina Parkway and the future Gaylord Chula Vista Hotel and Convention Center to the west, and the remainder of the Collins Aerospace facility to the east and north. An existing rail line is present along the eastern border of the property. The site is currently occupied by a large industrial warehouse building along with several small ancillary buildings and structures, and an on-grade asphalt concrete and Portland Cement concrete parking lots along with other associated improvements. Additionally, a San Diego Gas & Electric substation is

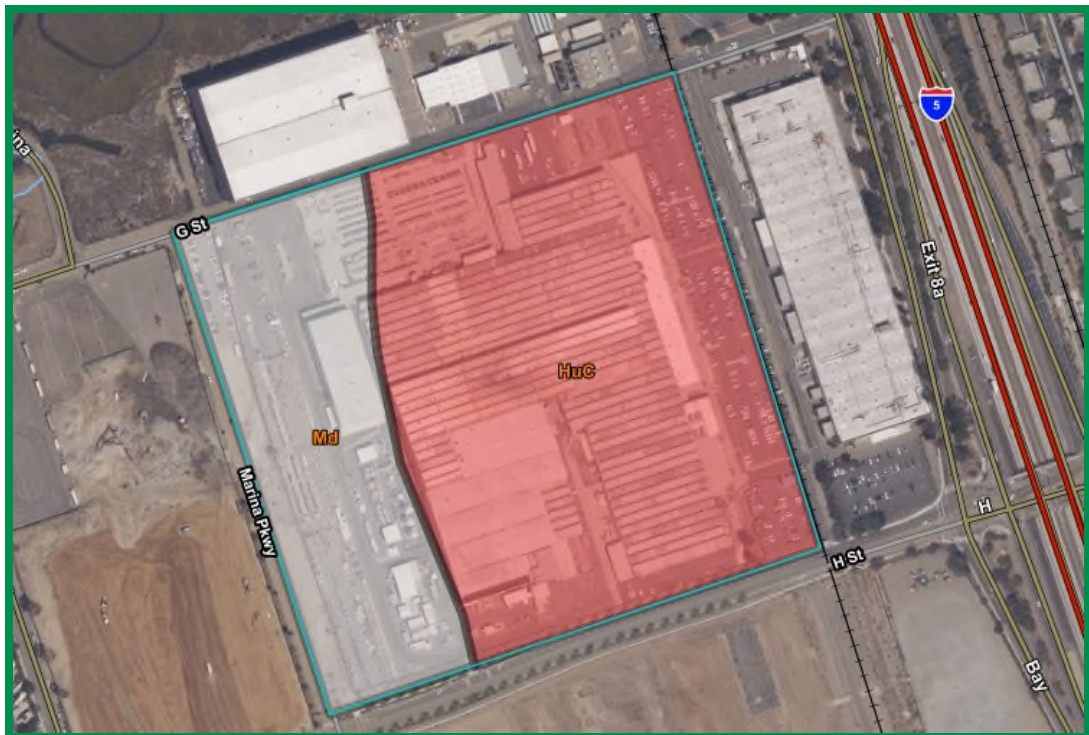
USDA Hydrologic Soil Group Map

7.5.2 Based on information from the USDA, the eastern portion of the property is designated as Huerohuero Urban Land Complex (2 to 9 percent slopes) and is classified as Soil Group D with a saturated hydraulic conductivity rate of 0.00 to 0.06 inches per hour, as shown on the USDA Hydrologic Soil Group Map. The western edge of the property is designated as Made Land which does not have a corresponding saturated hydraulic conductivity from USDA.

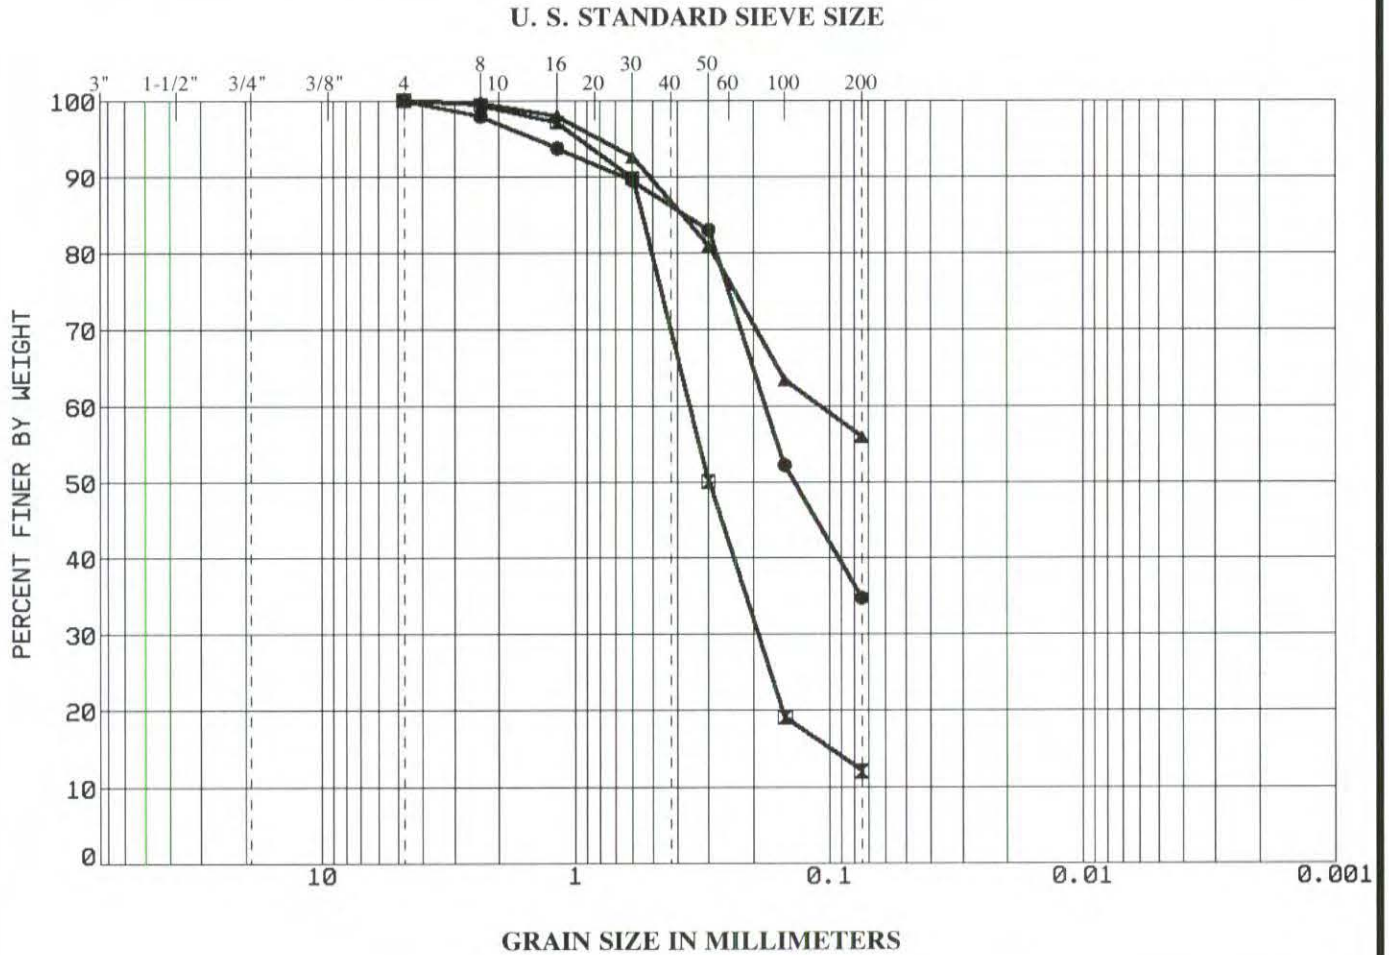
GRADATION CURVE

SAMPLE	Depth (ft)	CLASSIFICATION	NAT WC	LL	PL	PI
●	B6-4	10.0	(ML) Sandy SILT				
⊠	B6-6	20.0	(SM) Silty SAND				
▲	B6-10	40.0	(SM) Silty SAND
